## **Aquatic Resources Delineation**

**Subject:** Aquatic Resources Delineation – Dixon 257 Project, City of Dixon, Solano County, California. Report prepared for Steve Gidaro on behalf of 5G Consulting Group.

# **Aquatic Resource Delineation**

## Dixon 257, City of Dixon, Solano County, California

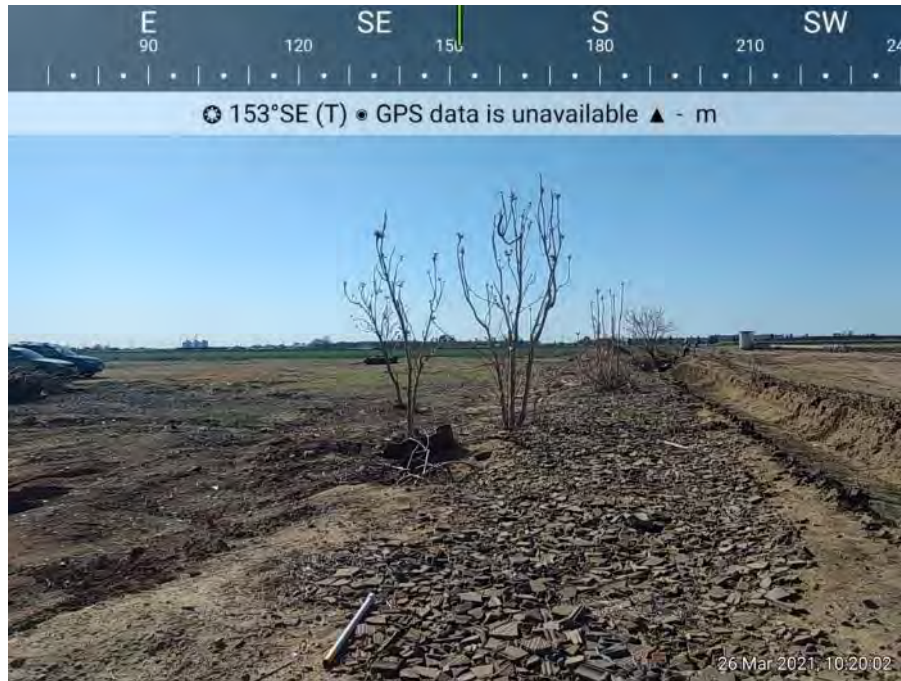
*Photo 1. Ditch-1 facing south with concrete debris in the foreground and ruderal/disturbed landcover typical of the Study Area.*

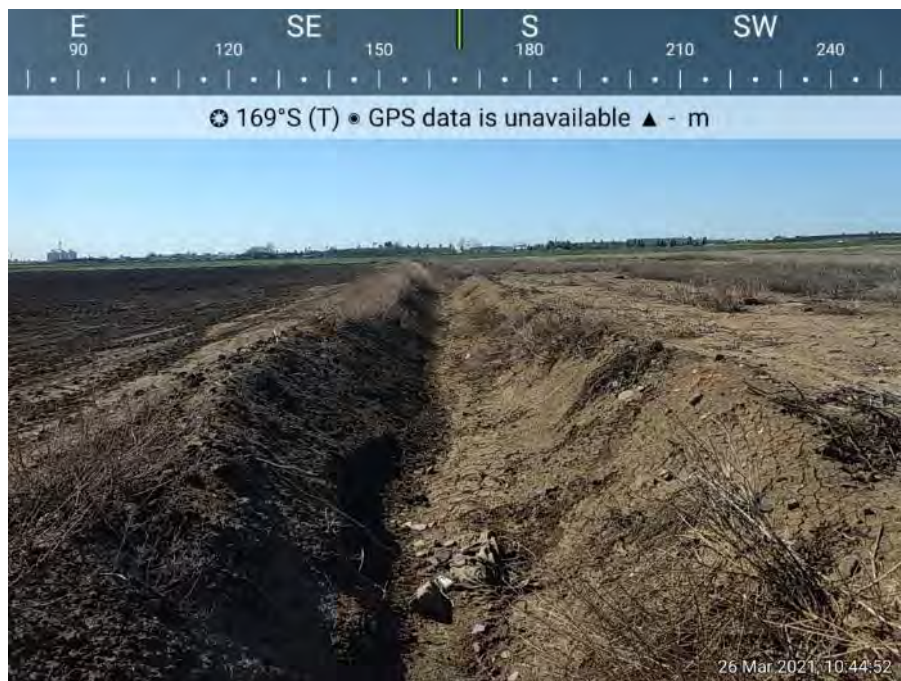
*Photo 2. Condition of agricultural irrigation and drainage ditches throughout the Study Area.*

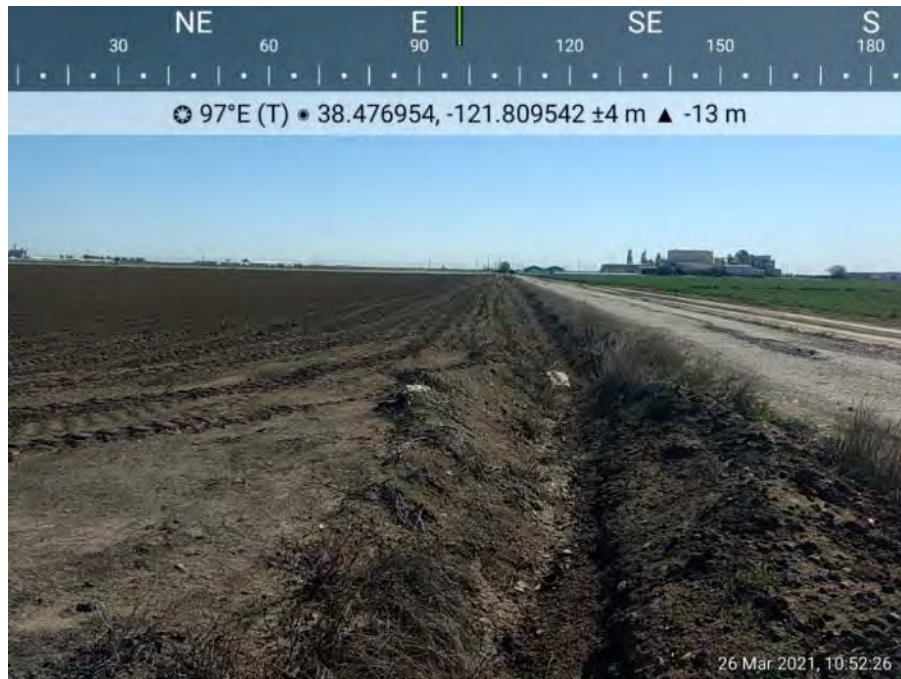
*Photo 3. Ditch-4 facing east toward Pedrick Road with field prepared for planting on the left and cover-crop on the right.*

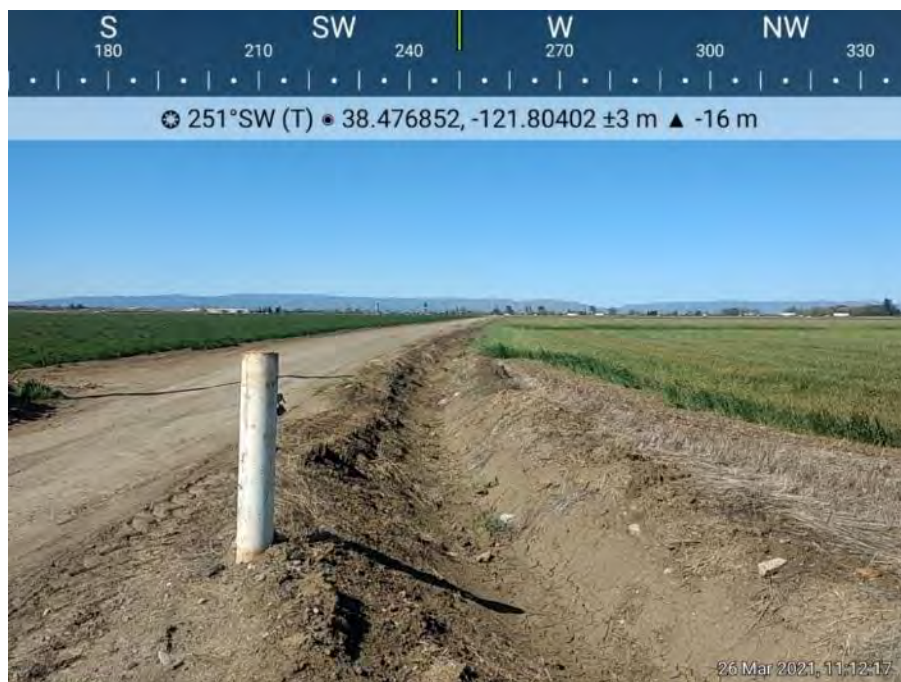
*Photo 4. Ditch-8 with row crops on either side of an access road. All drainage ditches were dry at the time of the survey.*

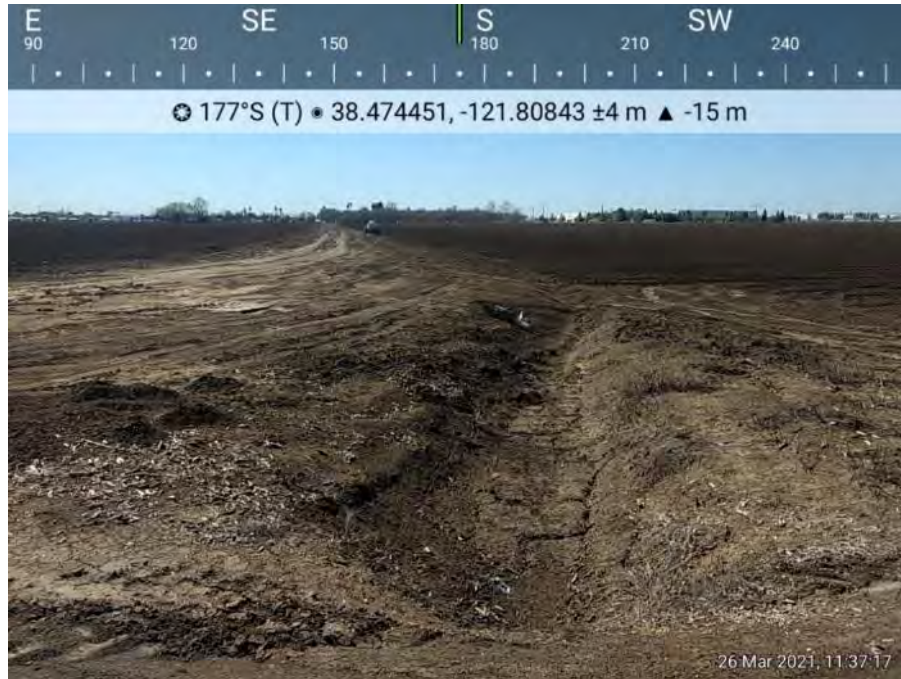
*Photo 5. Ditch-10 facing south with field prepared for planting on either side.*

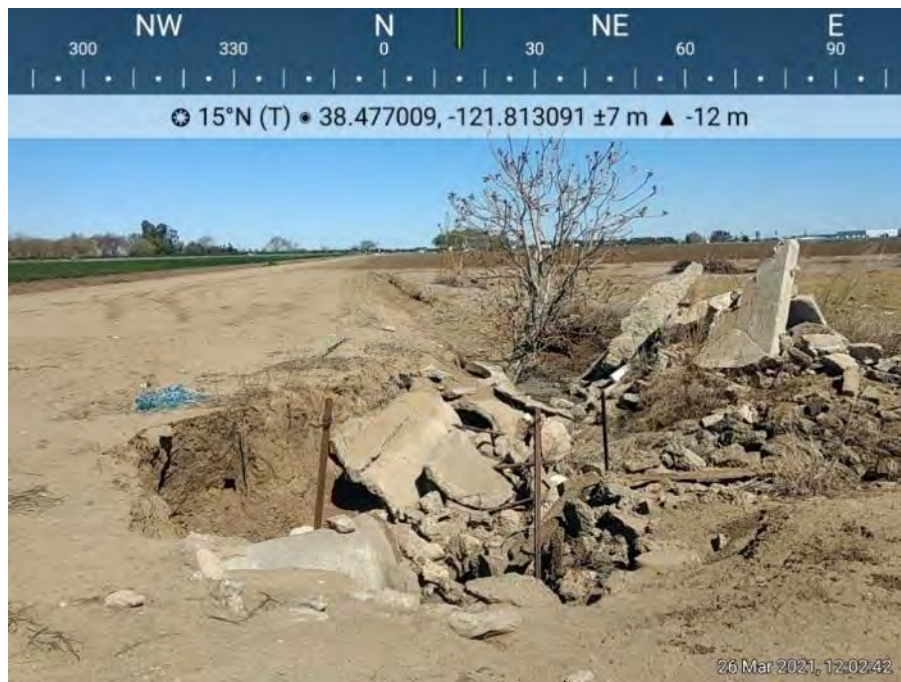
*Photo 6. Ditch-13 facing north with concrete debris and ruderal/disturbed landcover*

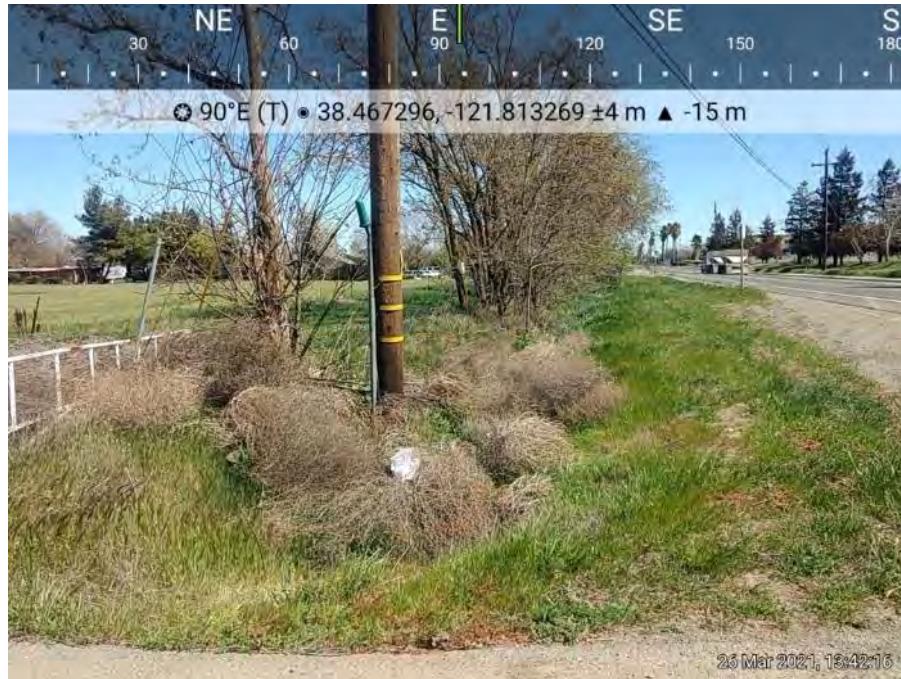
Photo 7. Ditch-17 facing east typical of *Avena* spp. - *Bromus* spp. Herbaceous Semi-Natural Alliance and *Lolium perenne* Herbaceous Semi-Natural Alliance.

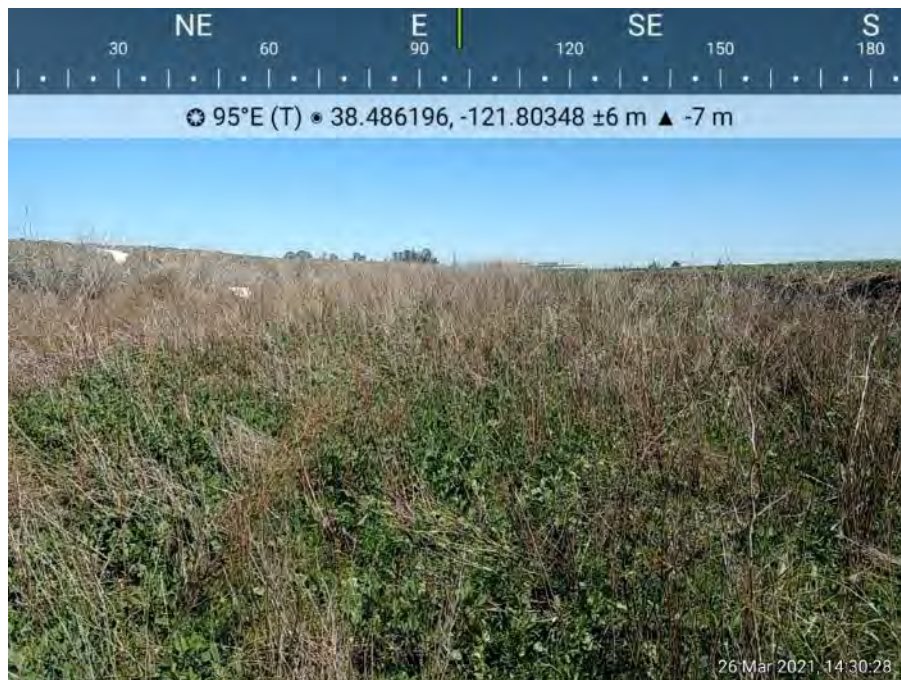
Photo 8. DP-1 facing east dominated by curly dock.

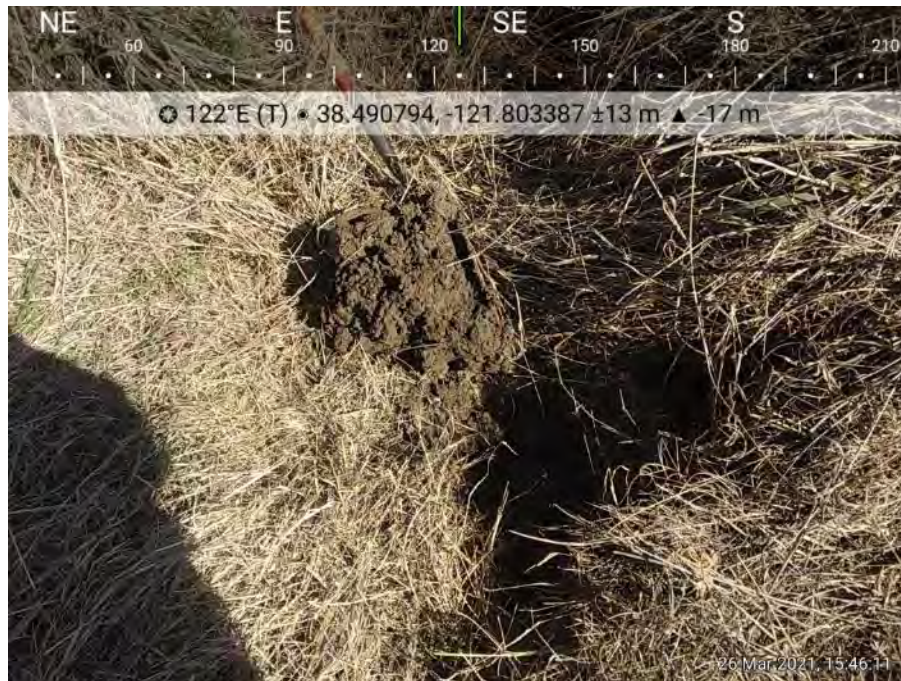
*Photo 9. DP-2 Sample pit location surrounded by unidentifiable senescent and early growth stage vegetation*

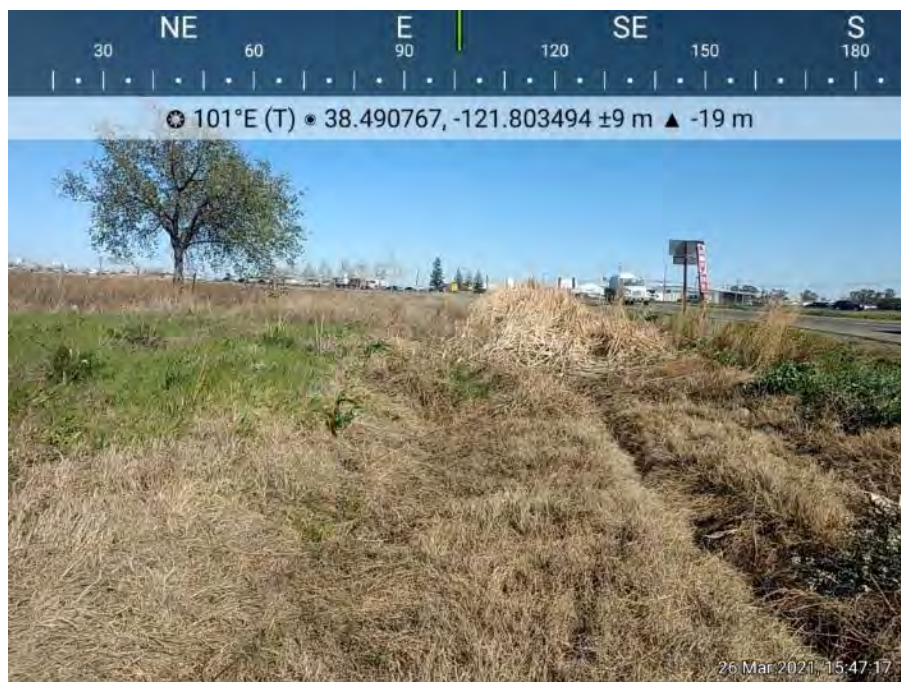
*Photo 10. View from DP-2 sample pit location facing east with stand of senescent broadleaf cattail in the background with the Interstate 80 offramp on the right.*

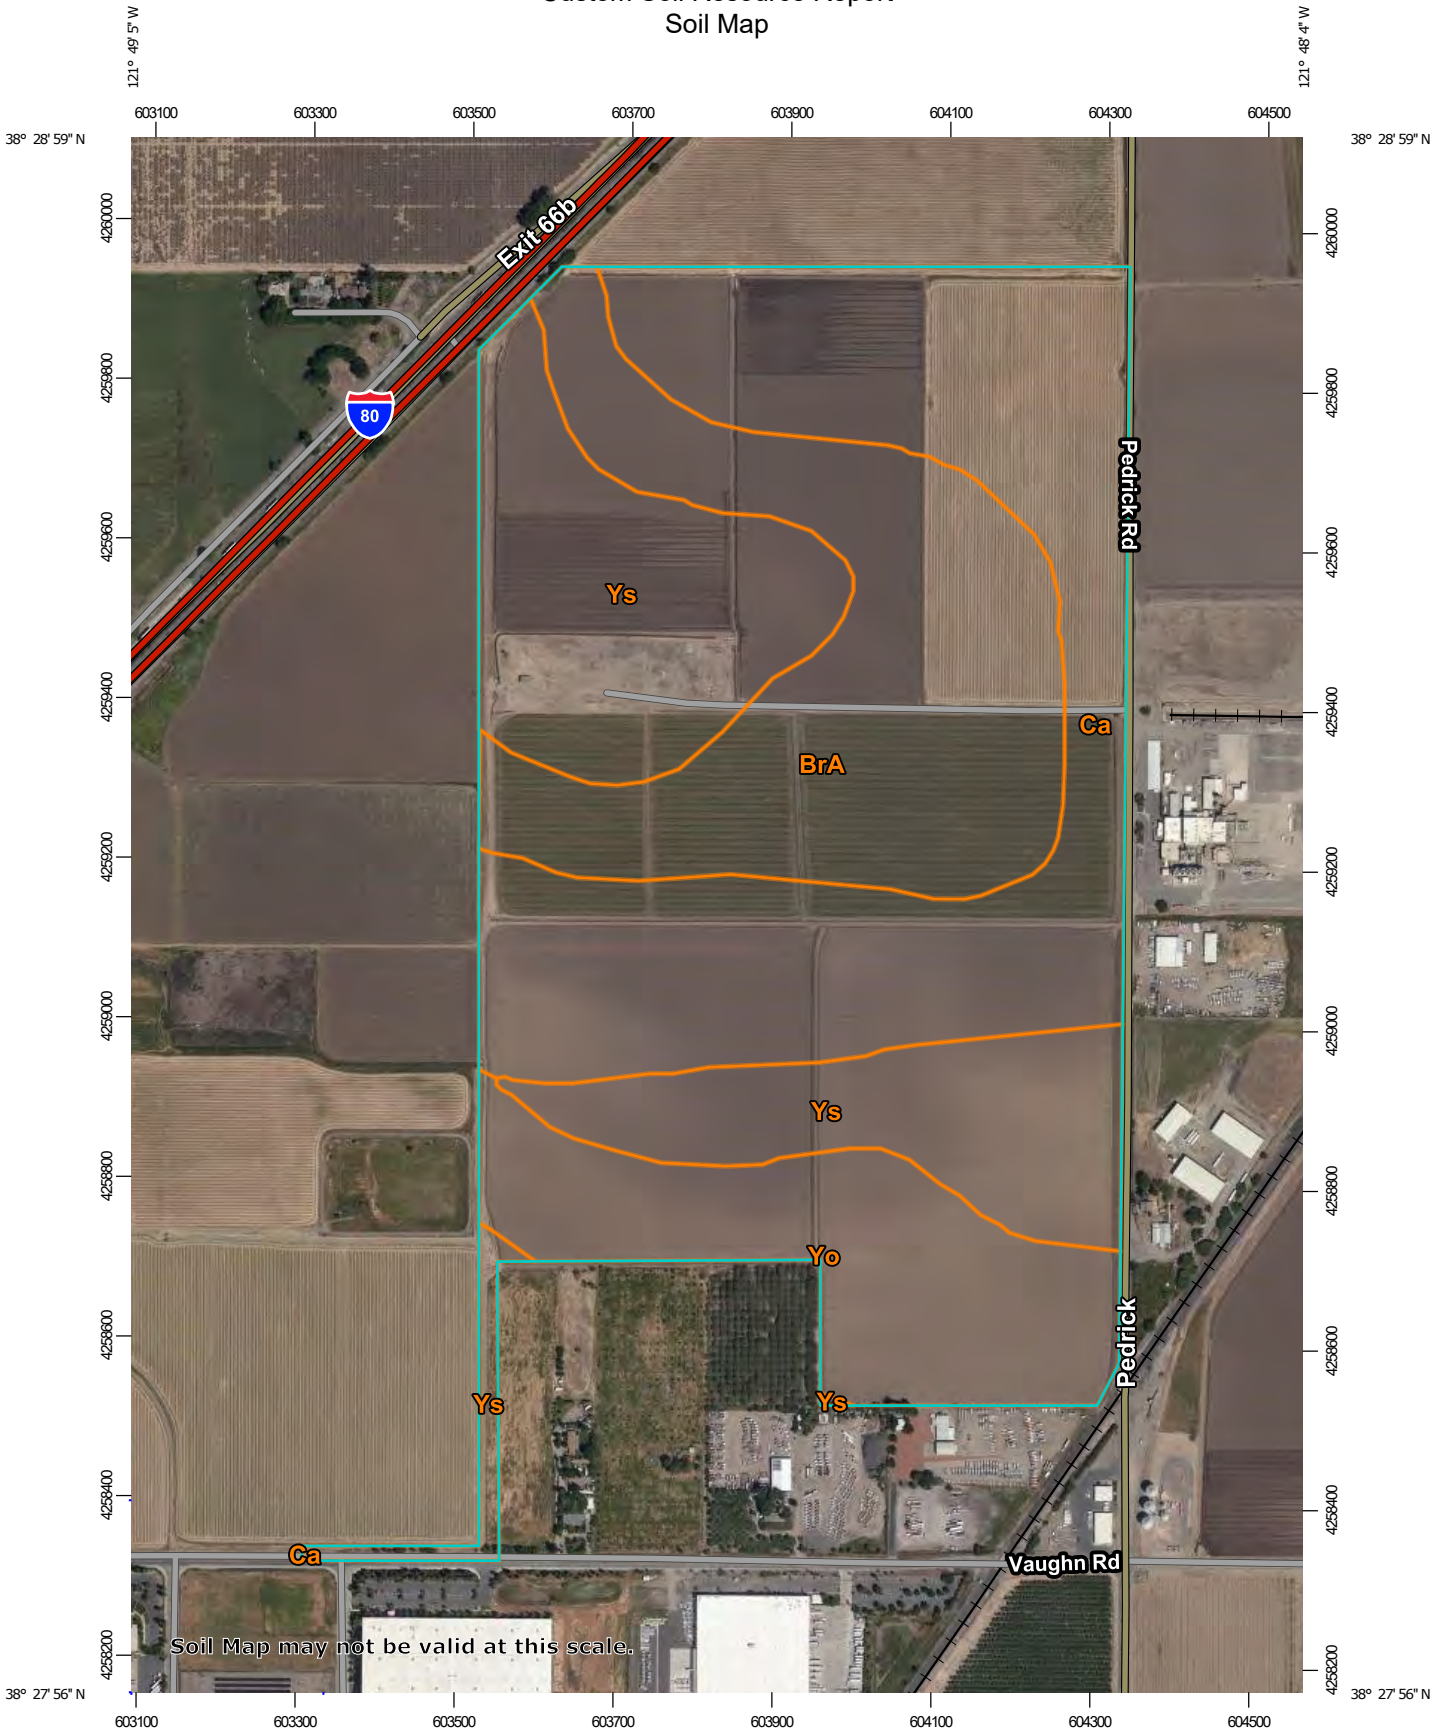
# Custom Soil Resource Report Soil Map

The soil map section includes the soil map for the defined area of interest, a list of soil map units on the map and extent of each map unit, and cartographic symbols displayed on the map. Also presented are various metadata about data used to produce the map, and a description of each soil map unit.

Map Scale: 1:9,500 if printed on A portrait (8.5" x 11") sheet.

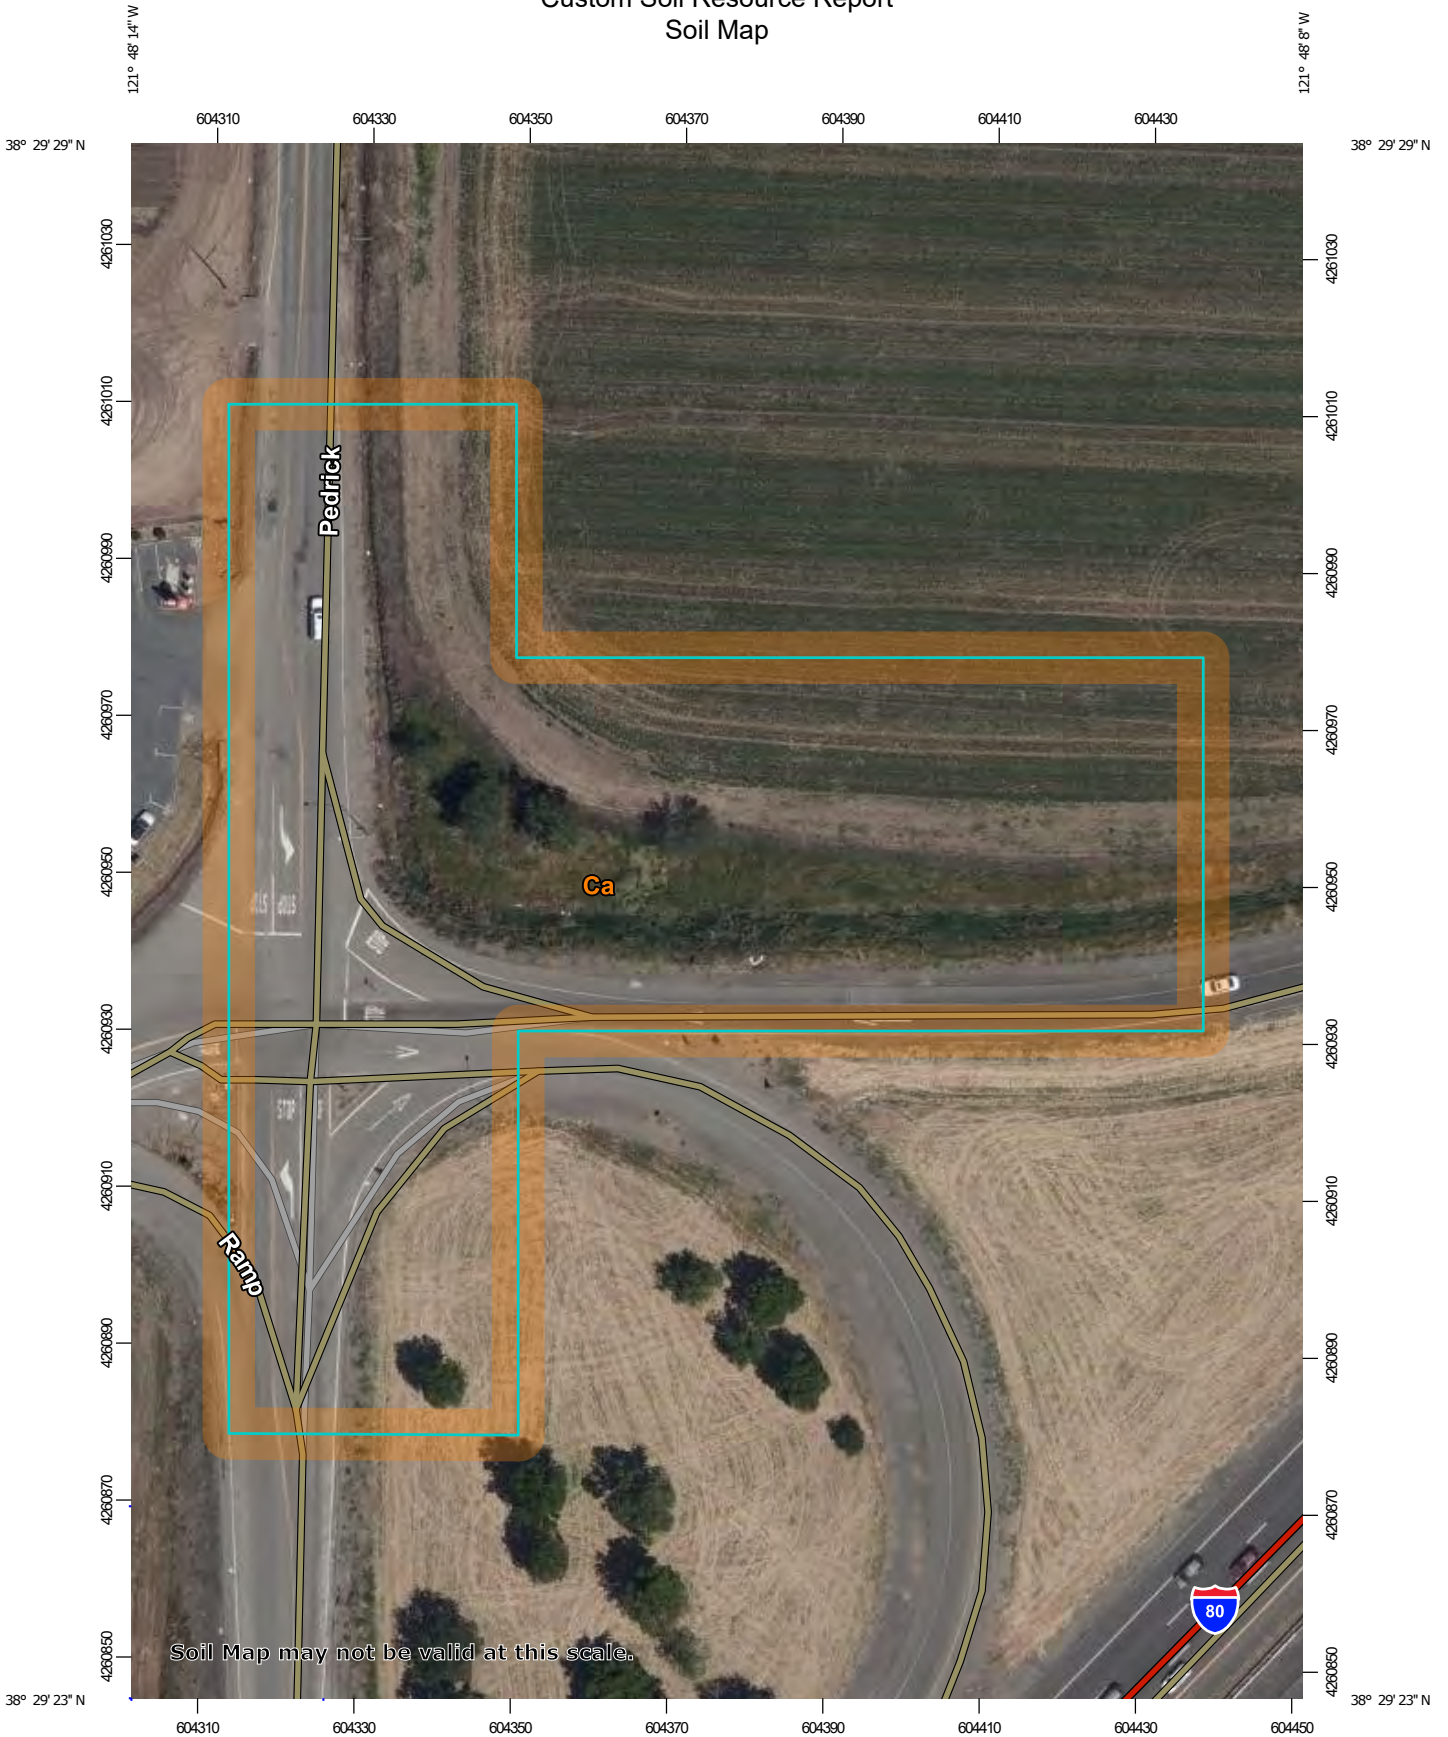
# Custom Soil Resource Report Soil Map

Map Scale: 1:966 if printed on A portrait (8.5" x 11") sheet.
